W I L D L I F E C O R R I D O R A S S E S S M E N T

V E N T U R A S T A T E R O U T E 118

F I R S T Q U A R T E R R E P O R T

May 27, 2003

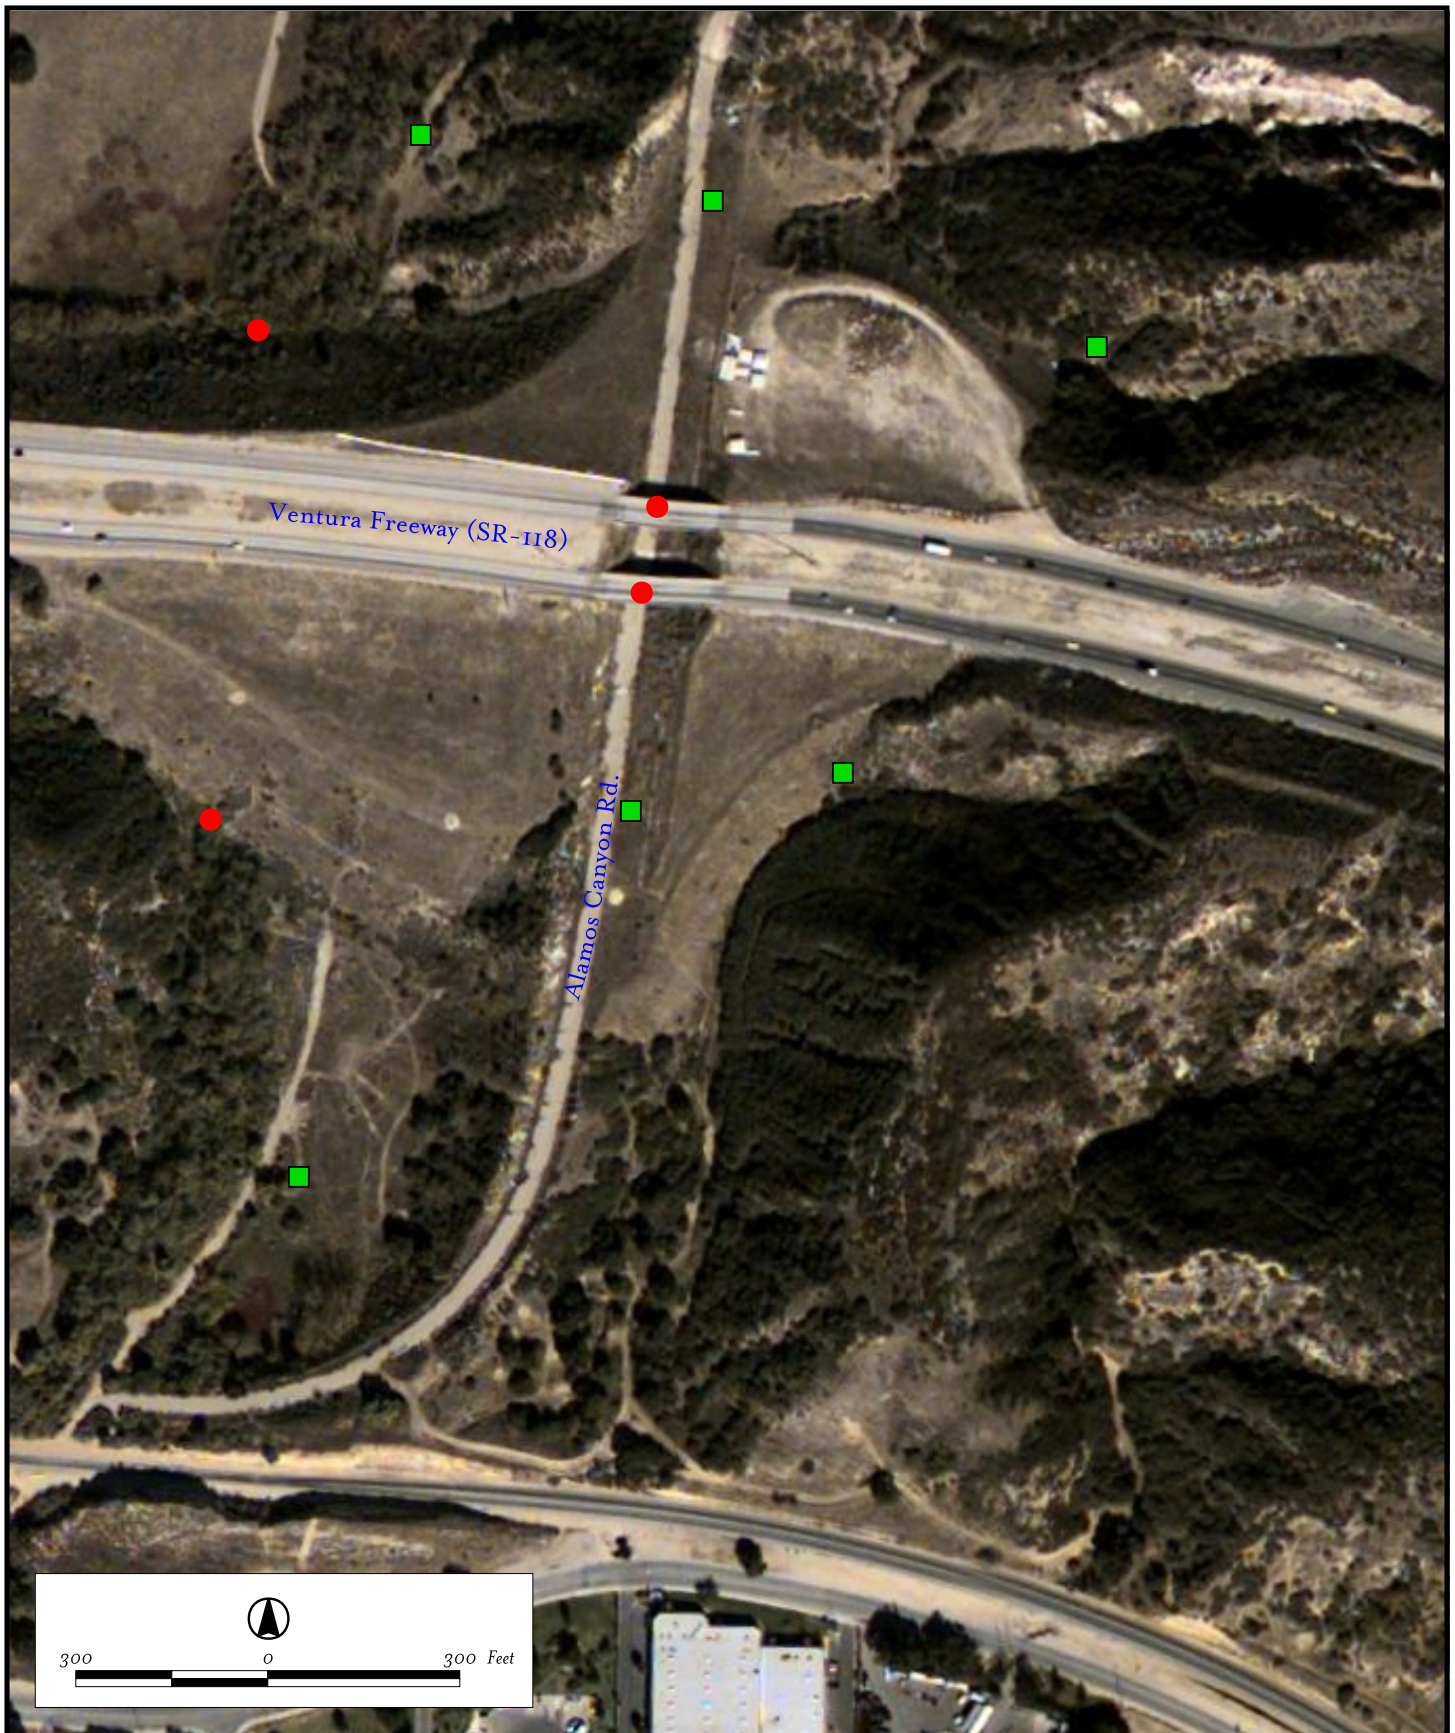
Figure 4

Alamos Canyon West RC Culvert; Alamos Canyon Underpass; Alamos Canyon East Pipe Culvert

Automated photo stations (Trail Master Trail Monitors) were set up at each end of the wildlife crossing, as listed in Appendix B, Table C, and depicted in Appendix A, Figure 2. The location of each camera station is shown in Appendix A, Figures 3 through 13. Schematics of the camera station installations are

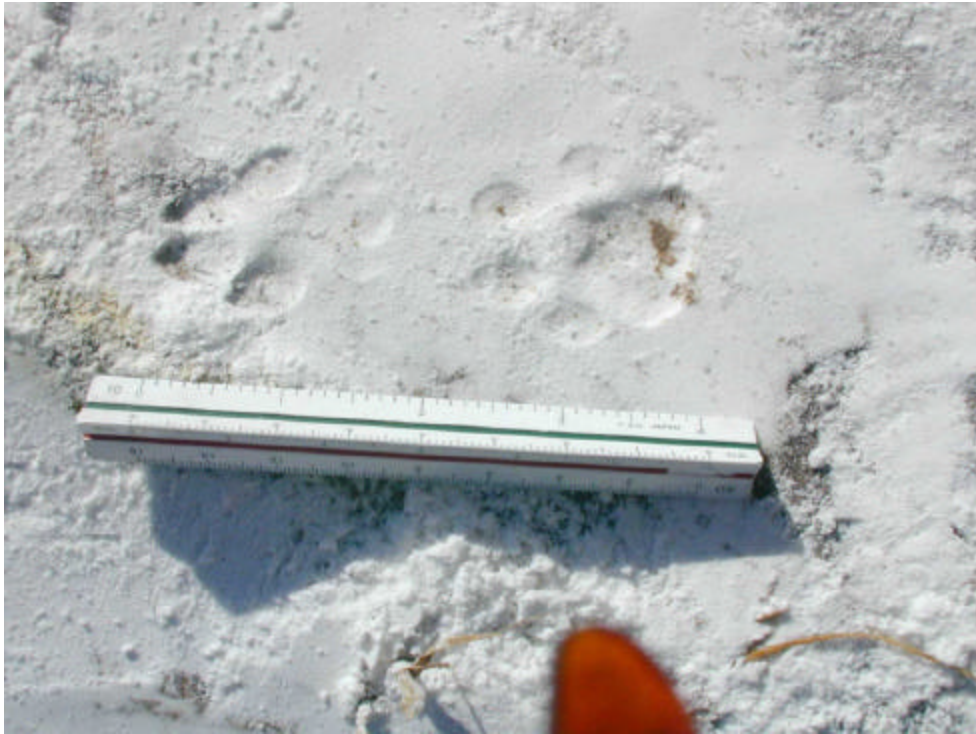
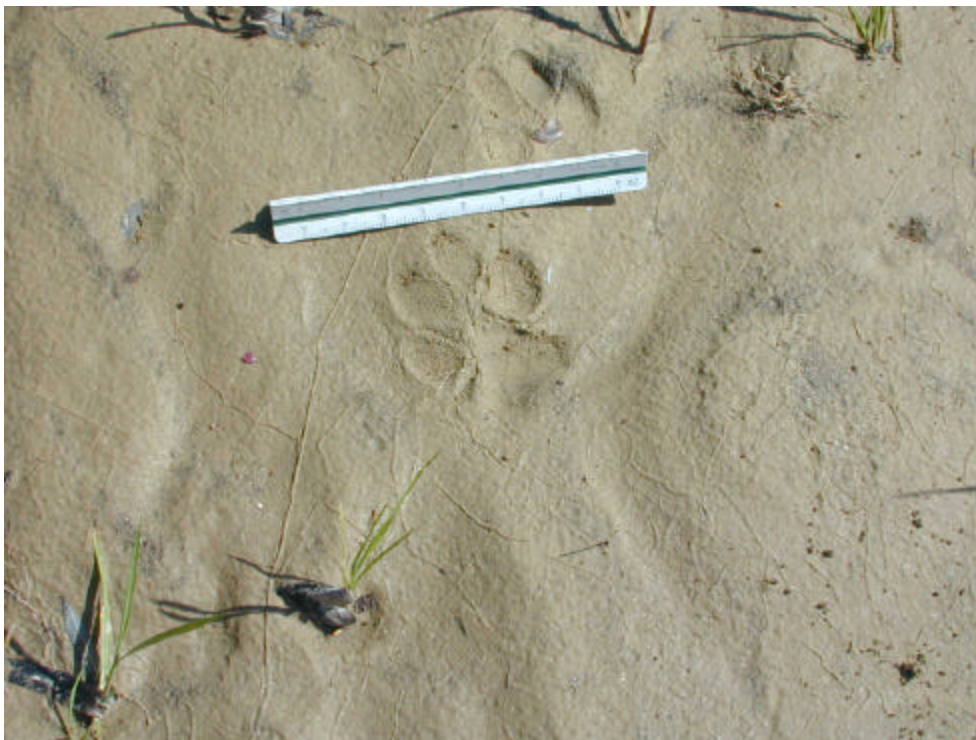
Figure 14

Bobcat track at East Alamos North station.

Coyote track at Browns Creek.

Ventura 118 Wildlife Study
Track Photographs

Scent stations attracted a variety of animals, including medium to large mammals. Target study species recorded at the scent stations included mountain lion, coyote, bobcat, skunk and opossum (samples shown in Appendix A, Figures 14, 15, and 16). Bobcat tracks were observed at scent stations located at Collins Drive South, Alamos Canyon North, Alamos Canyon South, Hummingbird Creek and Rocky Peak Road North. A bobcat was seen at Collins Drive south of SR 118 in the scrub along the railroad tracks. Coyote tracks were observed at scent station locations at Collins North, Alamos Canyon South, Rocky Peak Road South and Browns Canyon Creek North. A coyote was observed in the ravine south of Rocky Peak Road. Mountain lion tracks were observed at the Alamos Canyon North-East scent station and at the White Oak Park Open Space scent station.

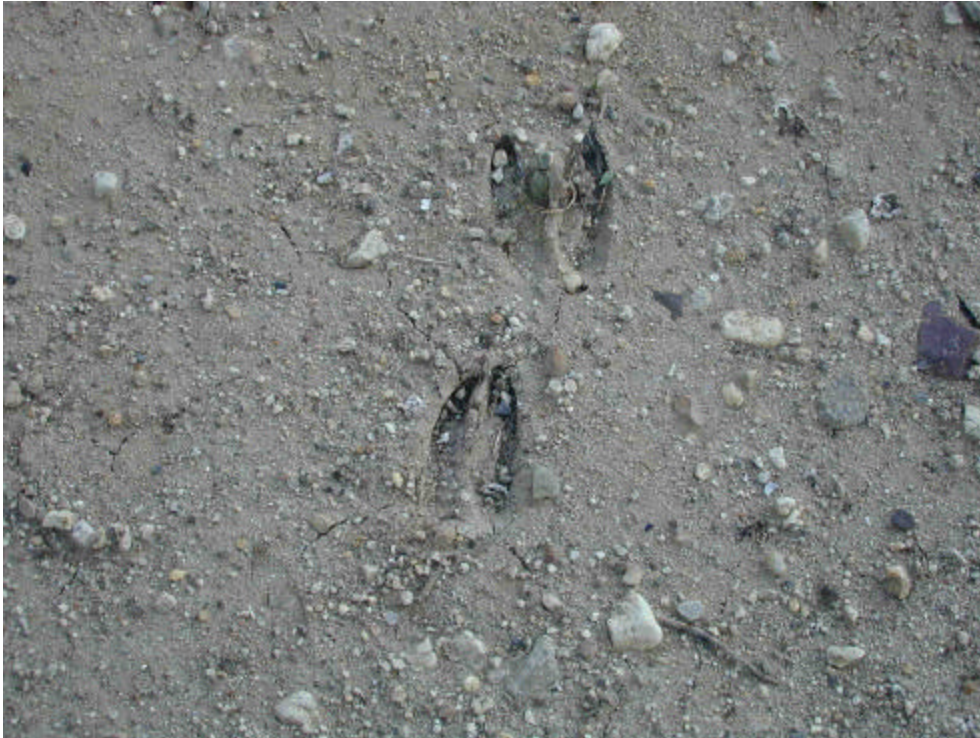
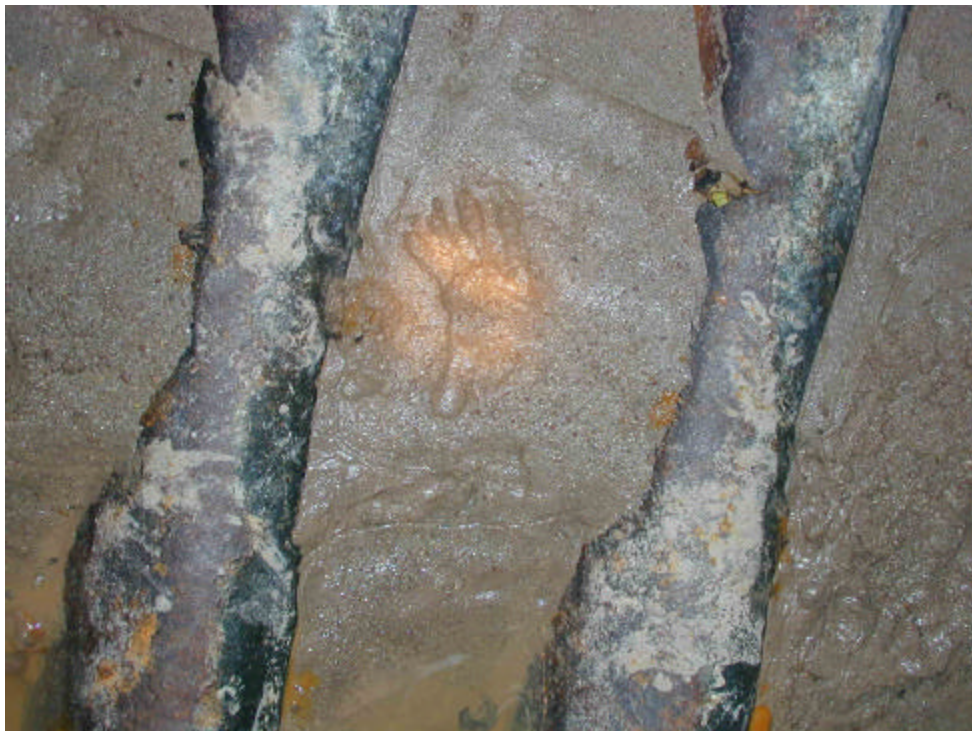
Figure 15

Deer tracks at Alamos Canyon crossing.

Opposum track at East Alamos CMP.

Ventura 118 Wildlife Study
Track Photographs

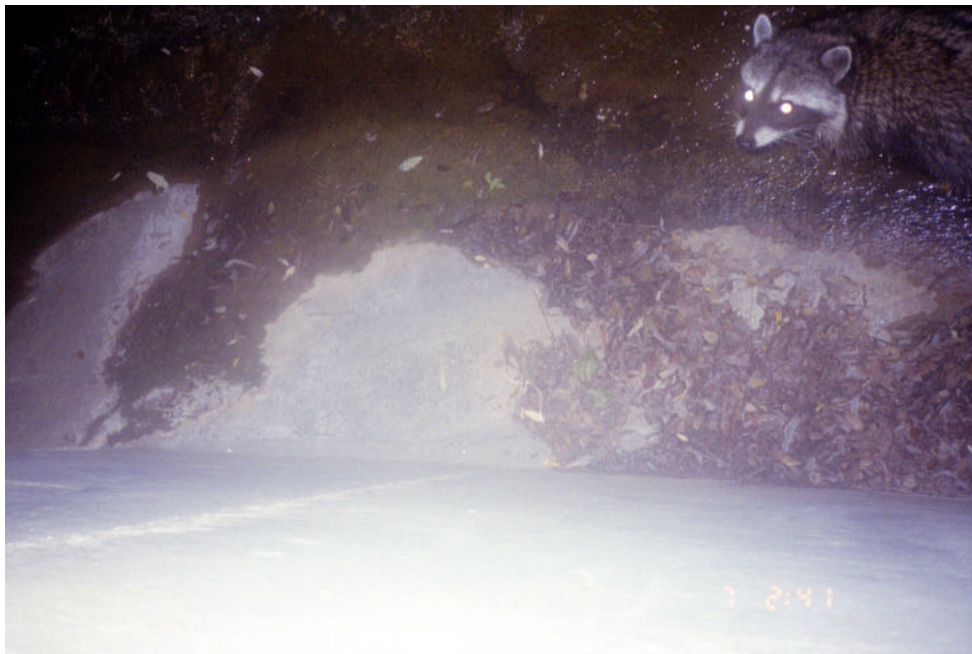
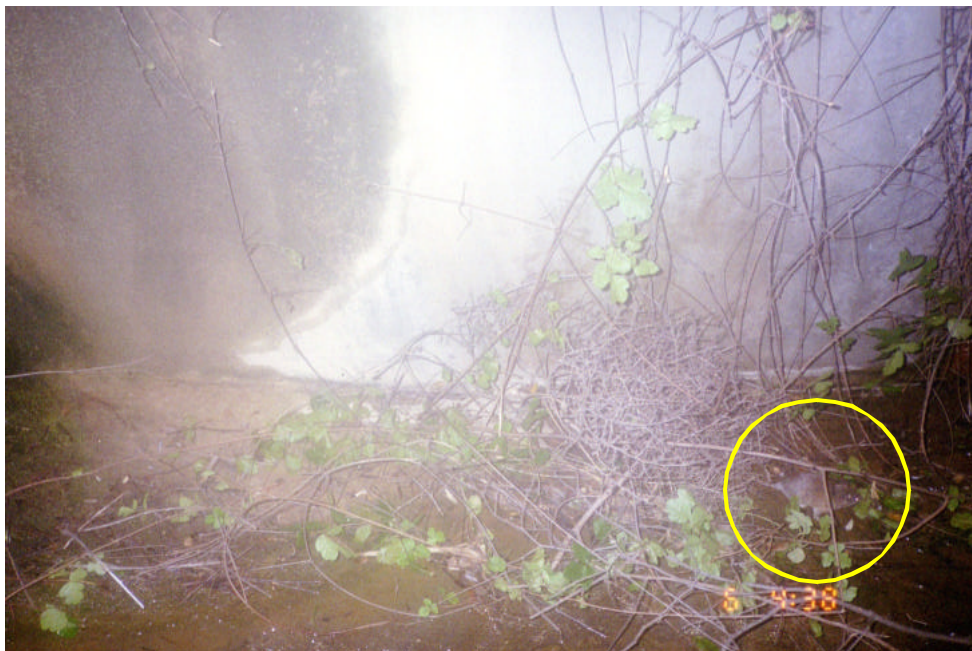
Figure 17

A raccoon is captured on film in the northern section of the Santa Susana Pass culvert.

Camouflaged amongst the debris and vegetation, a rat (*Rattus* sp.) at the Santa Susana Pass culvert.

Ventura118 Wildlife Study
Camera Station Photographs

The photo stations recorded skunk and raccoon (samples shown in Appendix A, Figures 17 and 18). The video photo stations primarily recorded human activities such as cars, hikers, horseback riders, and mountain bikers; however, a couple of ground squirrels and birds were also recorded (samples shown in Appendix A, Figures 19 and 20).

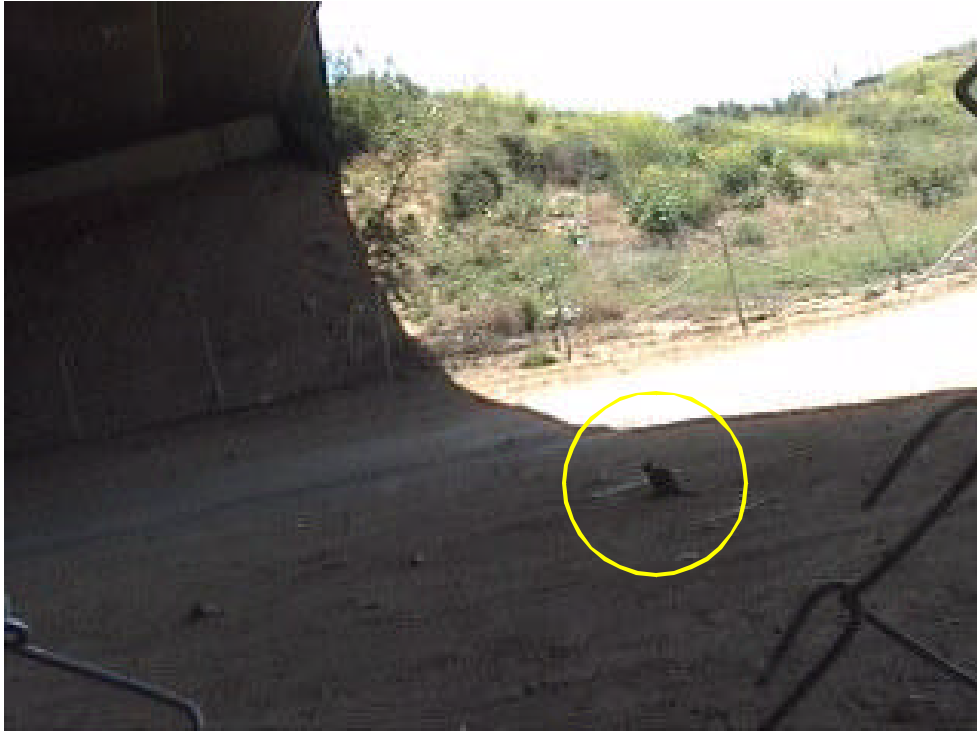
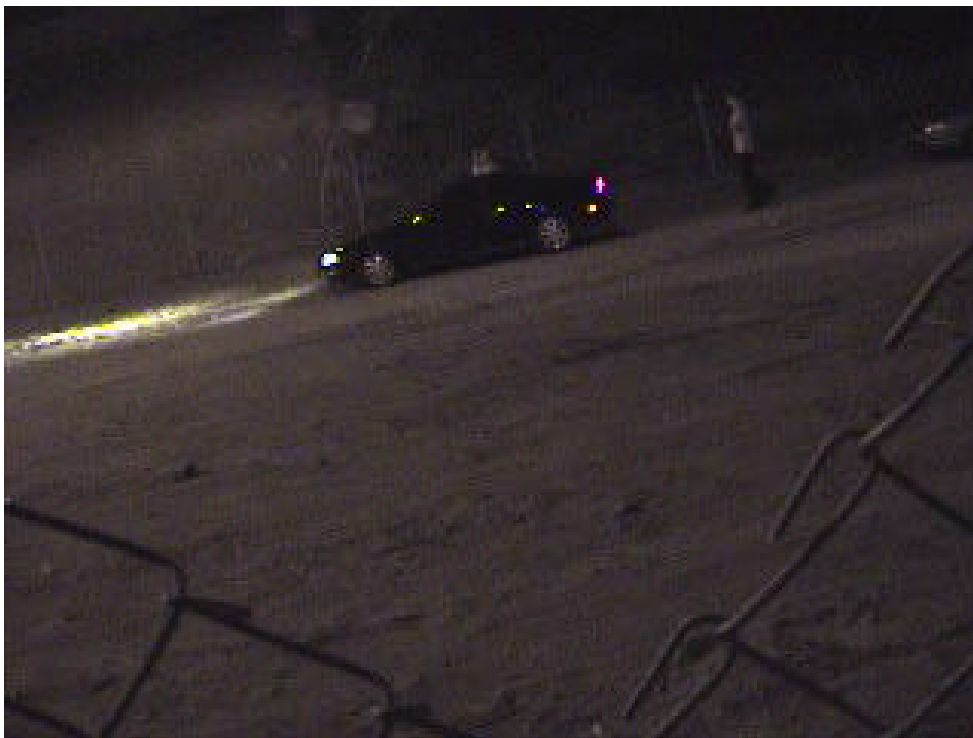
Figure 18

The active/passive sensor setup catches a BeecheyGroundSquirrel on video at the Canoga undercrossing.

The Canoga undercrossing experiences both pedestrian and vehicular traffic.

Ventura 118 Wildlife Study
Video Station Photographs

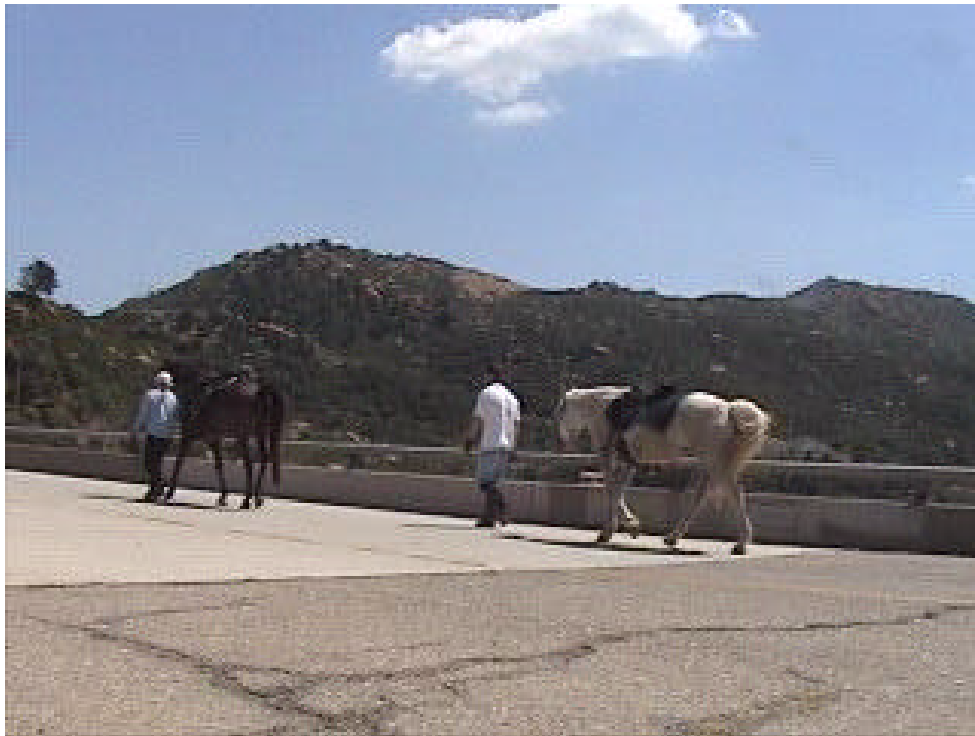
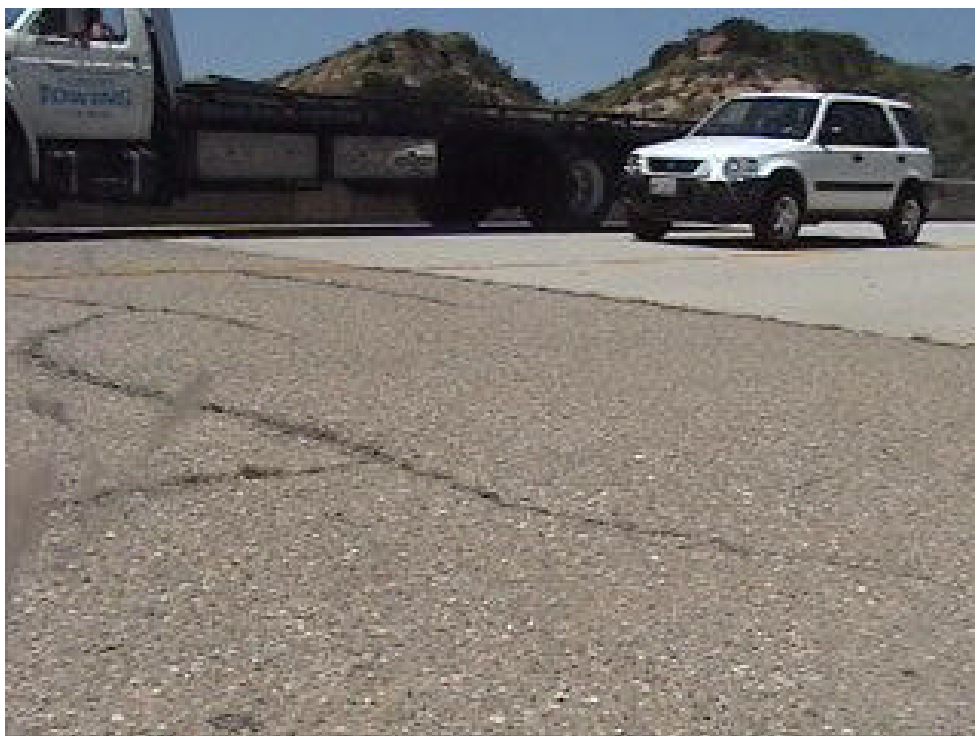
The video setup at the Rocky Peak overpass captures a pair of horses and their riders.

Vehicular traffic dominates the data collected via the video setup at Rocky Peak overpass.
